## Appendix H:

Analysis for Comm Tower Temporary Guy Removal

**Subject:** **Structural Stability Analysis Letter**

**Site Data:** **Anchorage School District, Anchorage, Anchorage Borough, AK**  
**Latitude 61° 18' 39.90", Longitude -149° 48' 47.50"**  
**180.0 Foot – Guyed Tower**

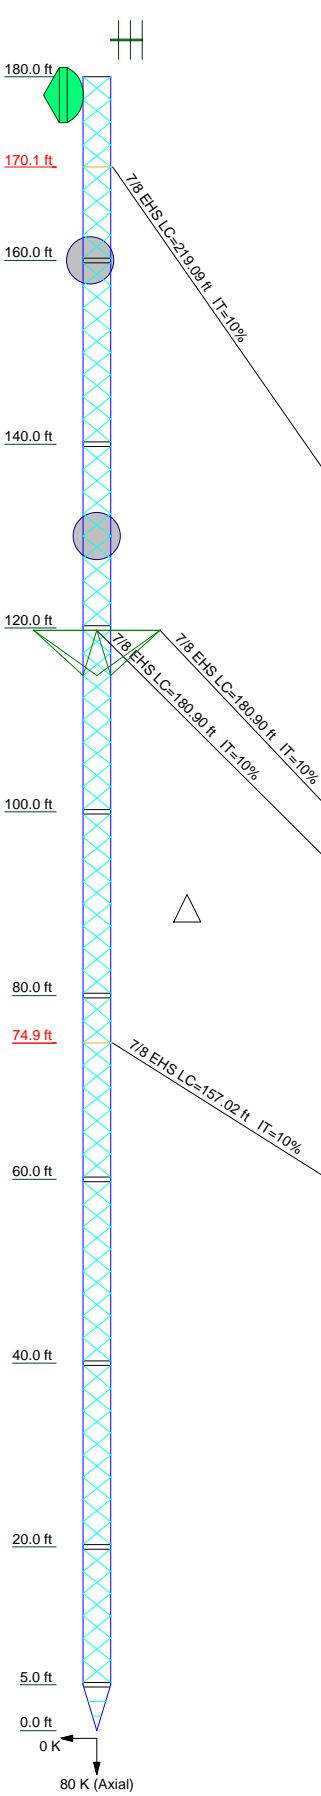
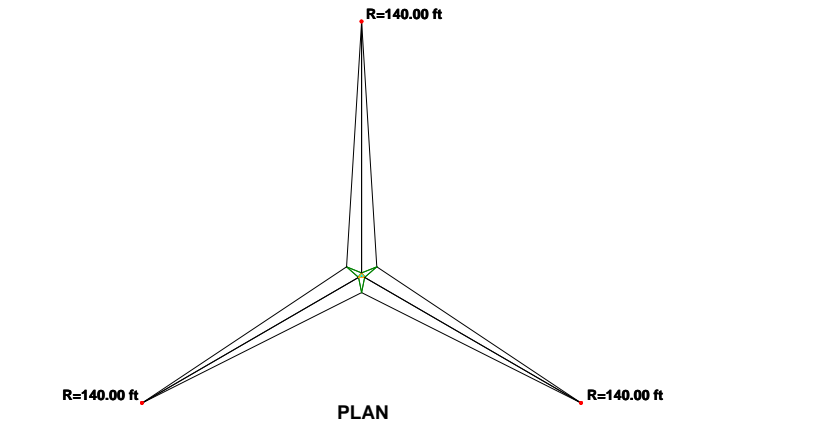
Dwg No. E-1

- TOWER DESIGN NOTES**
1. Tower is located in Anchorage County, Alaska.
  2. Tower designed for Exposure C to the TIA-222-G Standard.
  3. Tower designed for a 45 mph basic wind in accordance with the TIA-222-G Standard.
  4. Tower Structure Class II.
  5. Topographic Category 1 with Crest Height of 0.00 ft
  6. TOWER RATING: 45.2%

Non-Oper. Wind

- 45 mph 3-sec gust

- Phases Considered: Phase I

- Max Tower Capacity = 45.2% < 100%, OK

- Temp. Bracing is not Required

Based on our analysis, the **structure** possesses adequate strength and stability to support the construction activities and sequencing stated in the Table 2.1 once all requirements listed in Section 4.1 are fully addressed.
